Letter of Violation

Troyer Farms
Log # 3583
Para Miami Coun

CFO INSPECTION REPORT INDIANA DEPARTMENT OF ENVIRONMENTAL MANAGEMENT

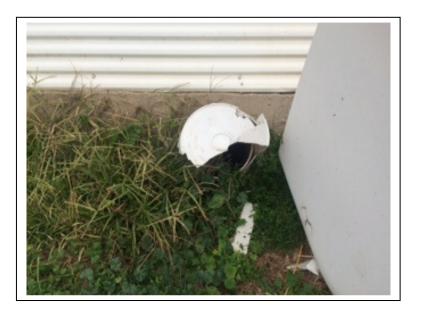
This photo shows a bucket that needs to be replaced in order to cover the pump out port located to the north of building labeled E-1 on the farmstead map.

Required Action: The waste management system must be repaired in such a way as to prevent excess water from entering the pits.

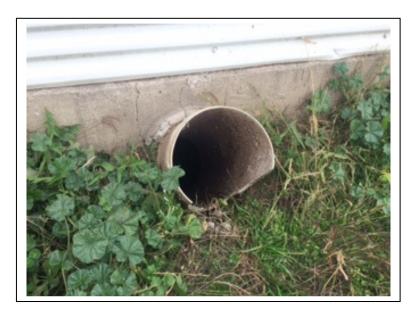
Violation Detail(s): One of the pump out ports on the south side of building labeled E-1 on the farmstead map is broken at grade which could potentially allow water to get into the pit (see attached photo). Several of the buckets covering the pump out ports are broken and need replaced (see attached photos).

This photo shows a broken pump out port that needs to be replaced in order to prevent water from entering the pit. This port is located to the south of building labeled E-1 on the farmstead map.

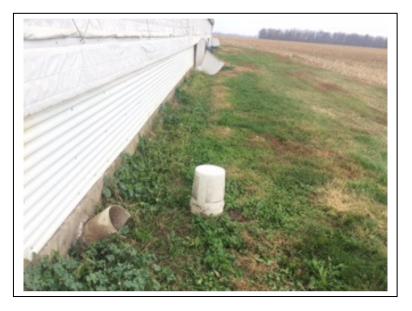
This photo shows a broken pump out port that needs to be replaced in order to prevent water from entering the pit. This port is located to the south of building labeled E-1 on the farmstead map.

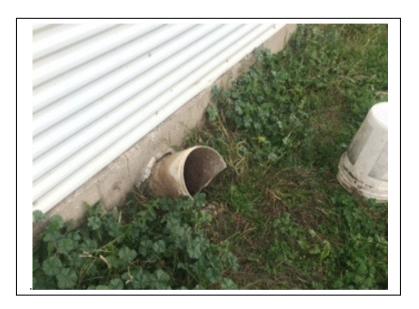
This photo shows a broken pump out port that needs to be replaced in order to prevent water from entering the pit. This port is located to the south of building labeled E-1 on the farmstead map.
